**Burro Cienaga Hydrological Monitoring Report,  
2007–2014**

Submitted to A. T. and Cinda Cole, Pitchfork Ranch  
by Ellen S. Soles  
Ellen.Soles@nau.edu

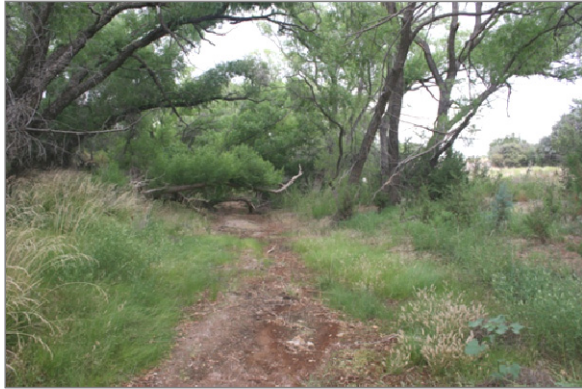
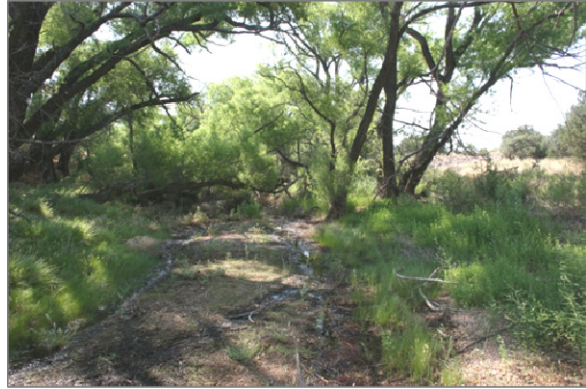
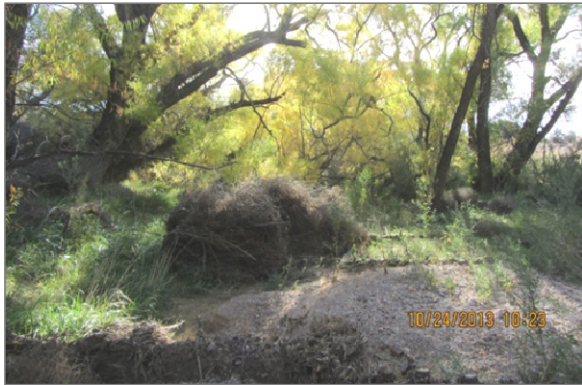
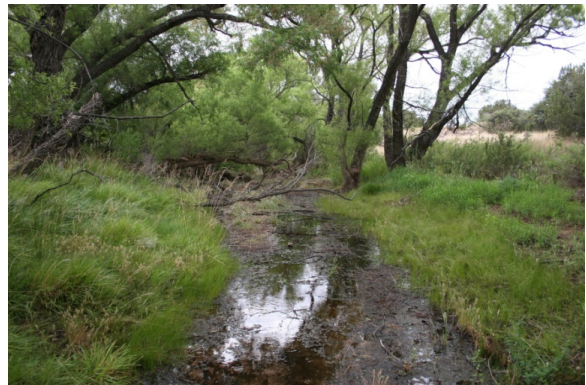
**Photo point 1, view downstream.**

**Clockwise from upper left: 2005.** Channelized corridor of Burro Cienaga at the upstream Pitchfork Ranch boundary. Diffused groundwater seepage through the left channel bank in this subreach sustained near-channel herbaceous and woody riparian vegetation, but obligate wetland species were absent. The channel was incised approximately 2 m below the historic wetland elevation. **2007.** Slight aggradation. **2010.** Increasing density of herbaceous wetland vegetation on floodplain, continued channel aggradation, and some obligate wetland plants colonizing areas at water's edge. **2013.** A series of woven weirs in this subreach are built up as the channel bottom aggrades; the three most recently constructed "tiers" are visible but nearly buried by additional aggradation. A scour pool (not visible) formed just downstream of the flood debris at left center, at the P1 transect.

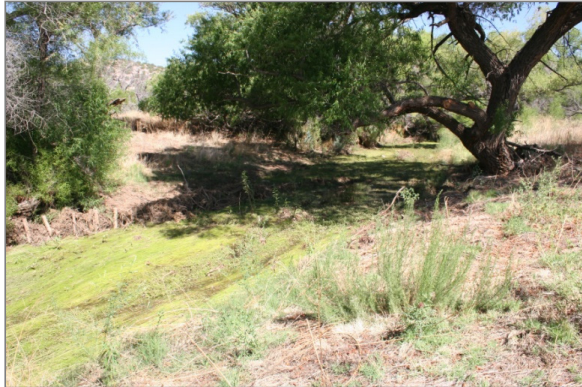
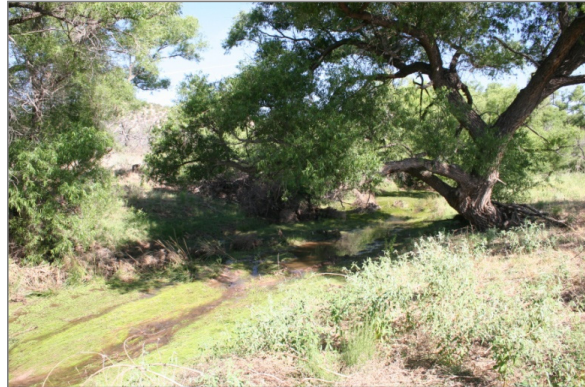
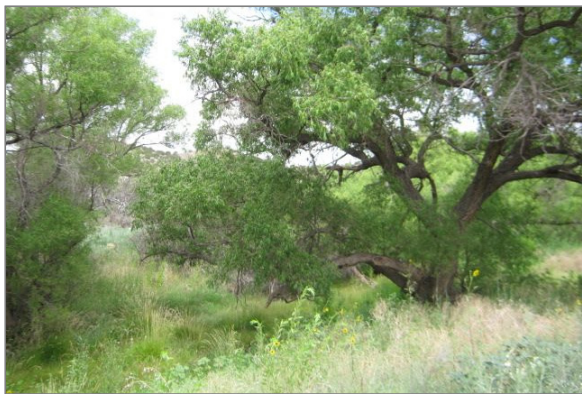
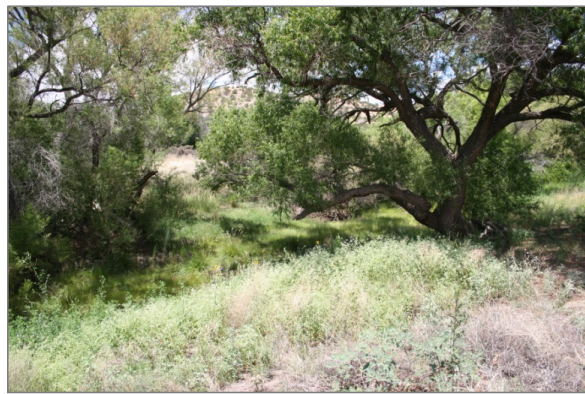
**Photo point 12, view upstream.**

**Clockwise from upper left: 2006.** A recently installed post baffle is visible on channel right (left edge of image). Sedge has colonized the channel bottom but the channel's steepness appears to increase the stream's velocity enough, even at low flows, to flatten this vegetation. **2008.** Deposition has partly buried the post baffle. **2010.** A variety of herbaceous and riparian species have colonized the low banks and cover on the higher adjacent terrace has increased. **2013.** Sedge and rush species still inhabit the area of surface flow, but dense ground cover vegetation is well-established across the floodplain and adjacent terrace.

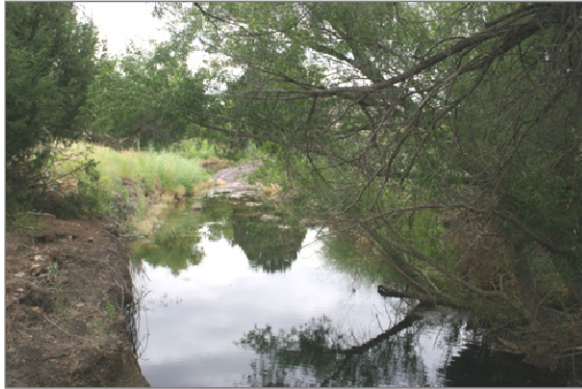
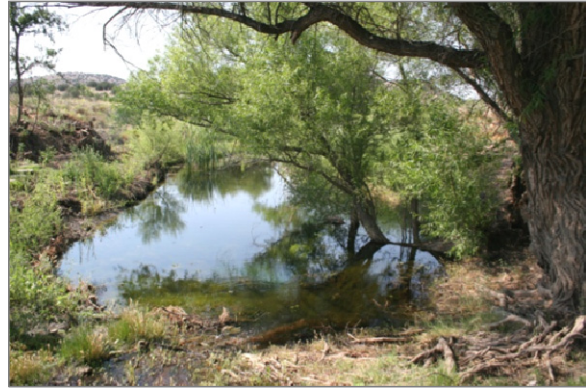
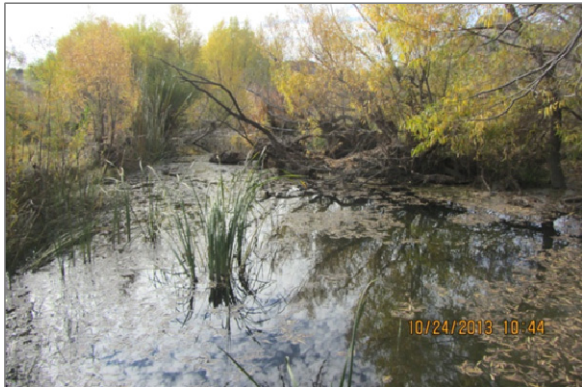
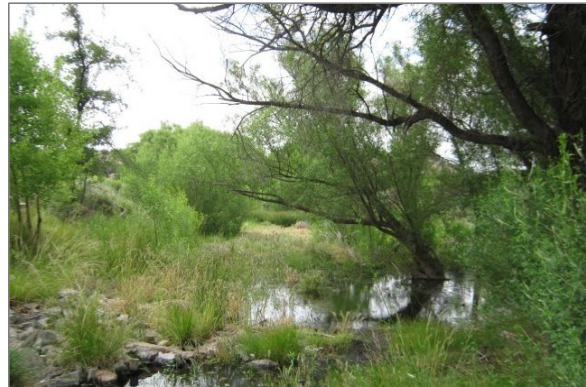
**Photo point 2, view downstream.**

**Clockwise from upper left: 2005.** A long deep pool formed at this location, but bankside vegetation recruitment was nonexistent; the few trees were decades old and the large juniper on the left bank suggests relatively dry conditions even within 2 m of the incised channel. **2007.** Some obligate wetland vegetation is beginning to establish at the site. Rock stabilization work at the upstream end of the pool enhanced deposition and was colonized by wetland plants, headcutting ceased. **2010.** Additional recruitment and growth of riparian and wetland vegetation. **2013.** Filling or re-scouring within the pool occurs during some floods, but its position remains stable despite evidence of very high-magnitude flooding at the site. Wetland and herbaceous vegetation is well-established.

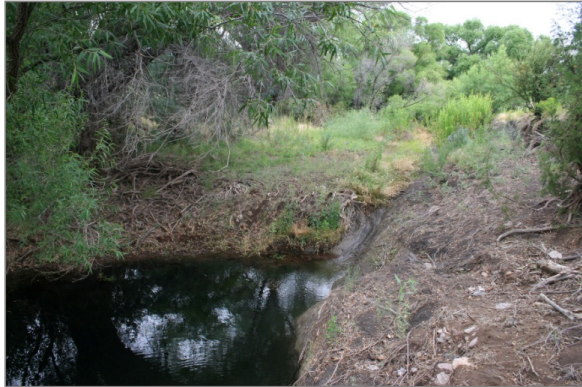
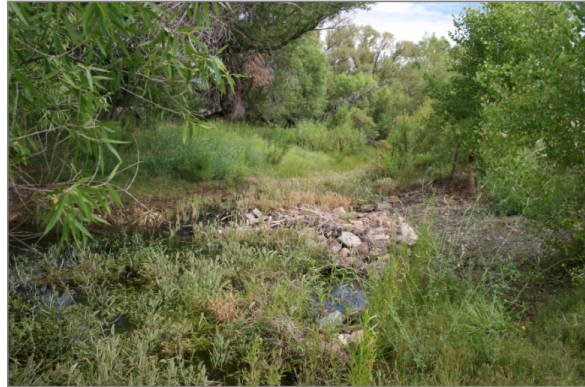
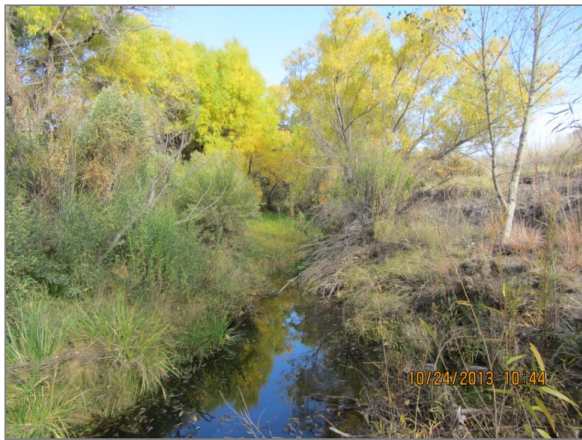
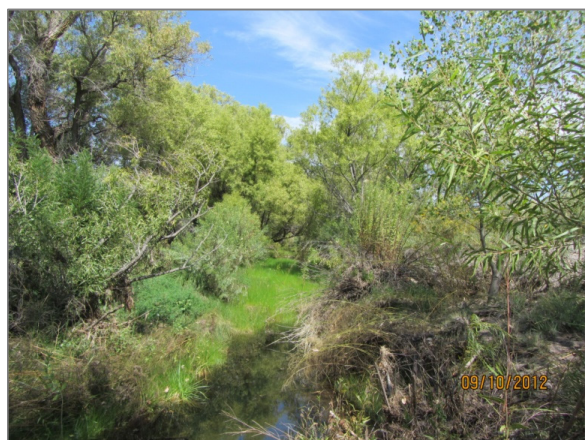
**Photo point 2, view upstream.**

**Clockwise from upper left: 2005.** Upstream end of the pool shown in previous photos; sparse herbaceous vegetation occupies the low right bank. **2009.** Stabilizing rock work at upper end of pool; herbaceous wetland species beginning to occupy floodplain. **2012.** Vegetation stabilizes and enhances deposition. **2013.** The right bank is densely vegetated with diverse vegetation, including herbaceous wetland species; vegetation density on the higher-elevation left bank has also increased.

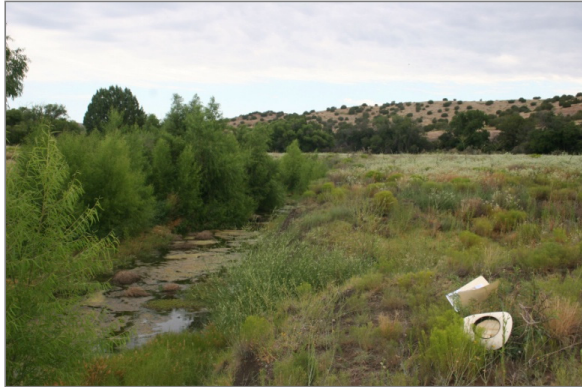
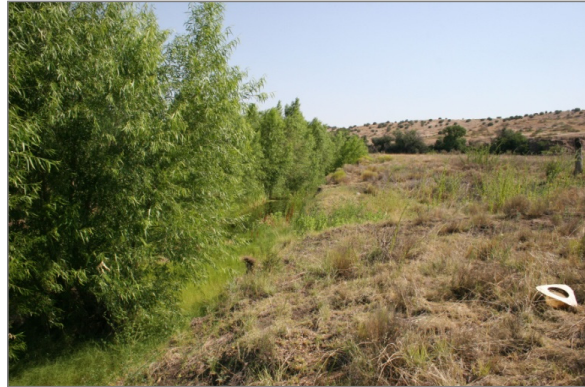
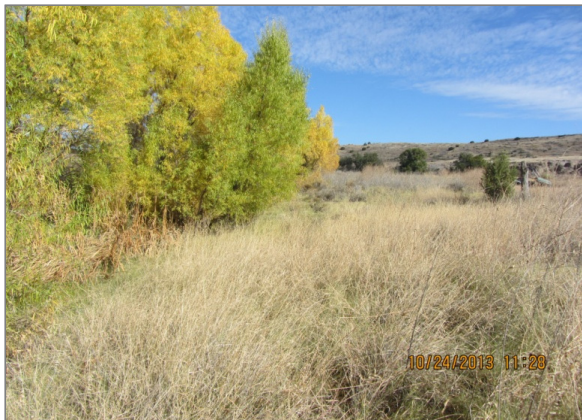
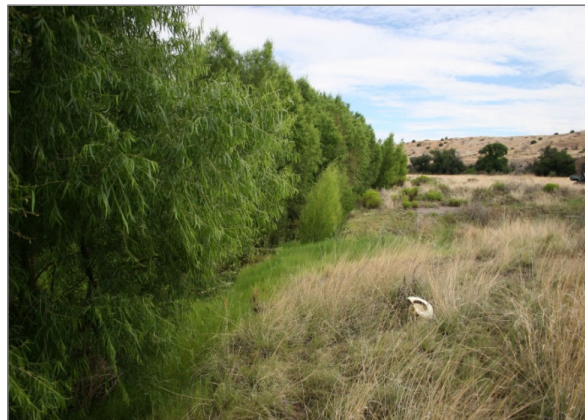
**Photo point 4, view upstream.**

**Clockwise from upper left: 2005.** Surface flow is present, and this view clearly shows the extent of channel incision below the elevation of the historic floodplain/wetland on the right half of the image. A side cut, visible just beyond the hat, has eroded through the left bank. Herbaceous vegetation is sparse, with many annual nonnative species present. **2007.** Streamside woody riparian vegetation is denser and taller; native herbaceous vegetation has expanded slightly upward toward the terrace level. **2009.** Increased ground cover in side headcut and riparian expansion. **2013.** Previously sparse stands of obligate wetland species on the left channel bank are denser and more extensive, and native grass cover on the left terrace has increased. Erosion in the left bank headcut has been arrested.

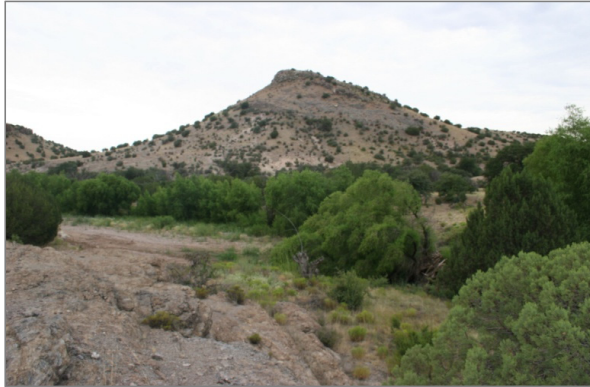
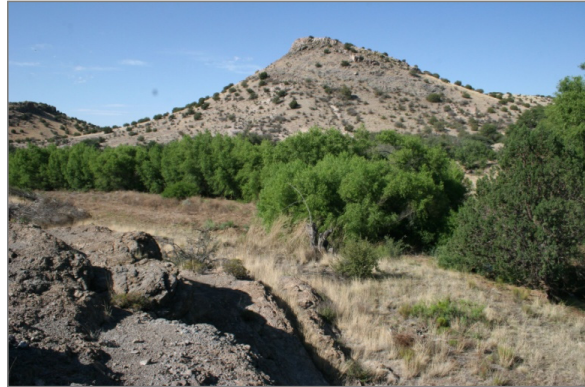
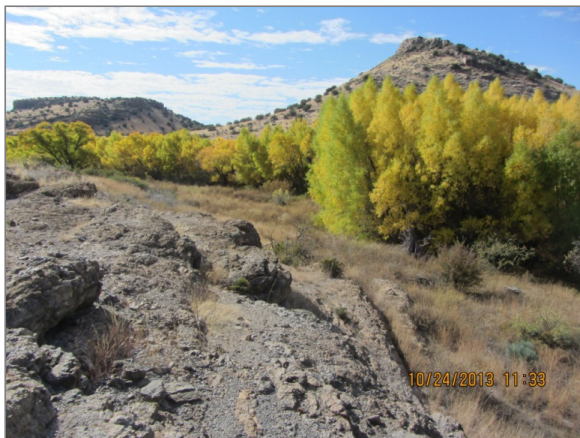
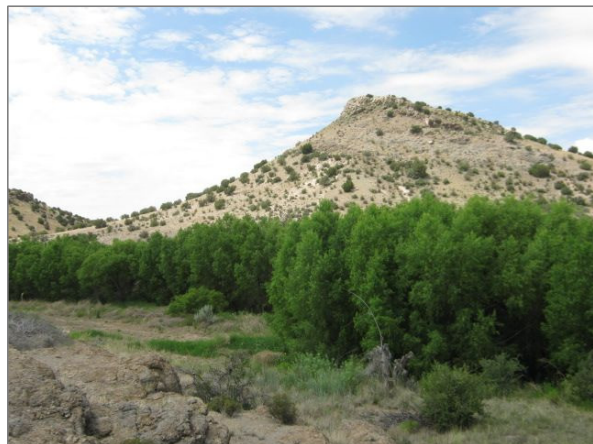
**Photo point 5, view downstream.**

**Clockwise from upper left: 2005.** The barren remnant of an historic road on the left floodplain is visible, left center of image. Restoration included closure of this road segment. **2008.** Some native grass and forb cover has re-occupied the old road surface. **2010.** Growth and expansion of woody riparian species cover. **2013.** Continued increase in native grass cover.

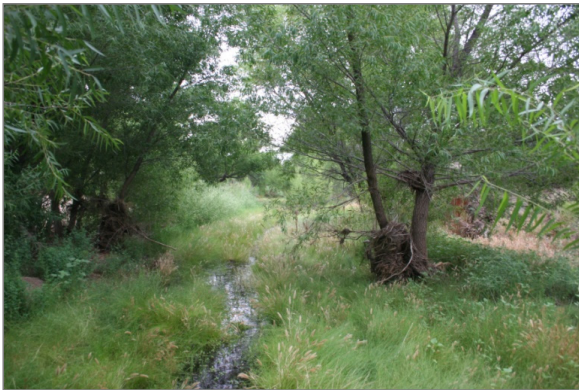
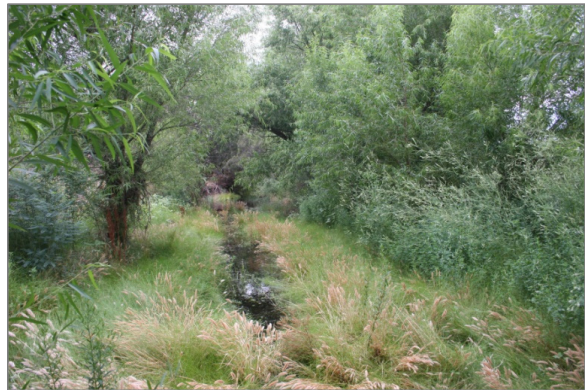
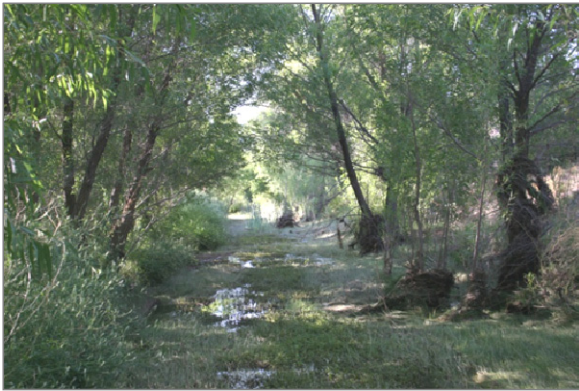
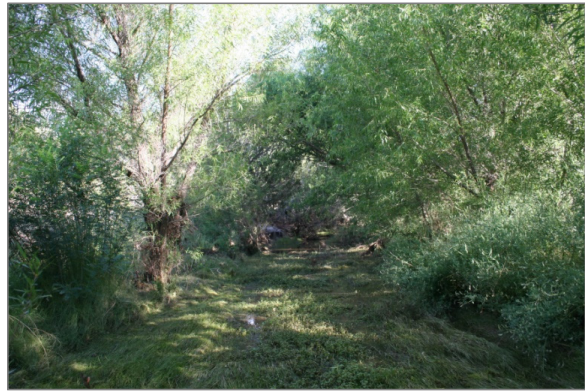
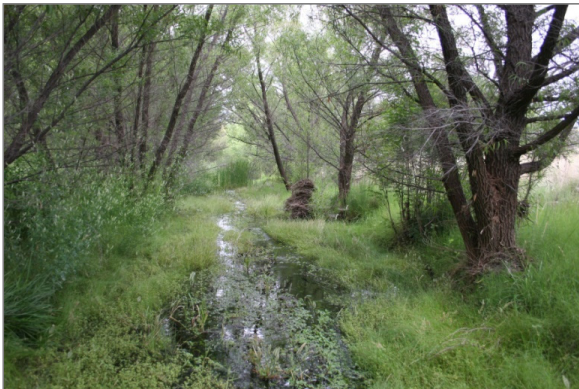
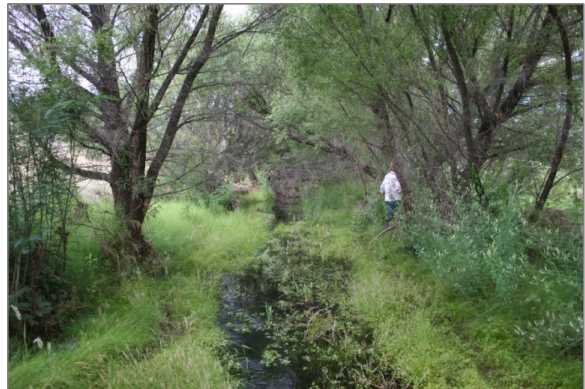
**Photo point 6, view downstream (left) and upstream (right).**

**Top to bottom:** Transition subreach between the historic Burro Cienaga (wetland), and the riparian zone characterized by intermittent flow downstream of Horse Canyon. Geologic controls constrain this subreach, through the alluvial fan at the base of Horse Canyon, and probably precluded farming the adjacent terraces. **2005.** Native grasses were the predominant ground cover. **2006.** Surface flows overtop the relatively low floodplain and terrace, and no substantial geomorphic channel change occurs during even high-magnitude floods. **2009.** Obligate wetland species (particularly sedge and cattail) are densely established through this subreach.

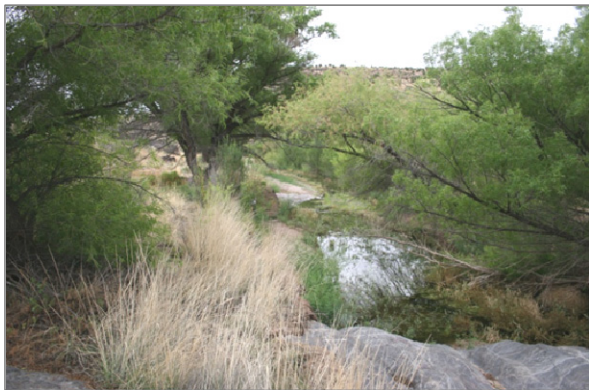
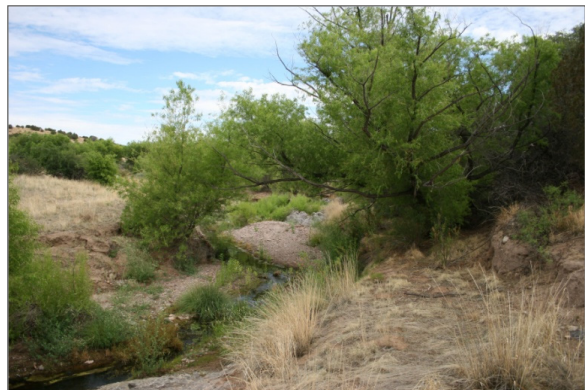
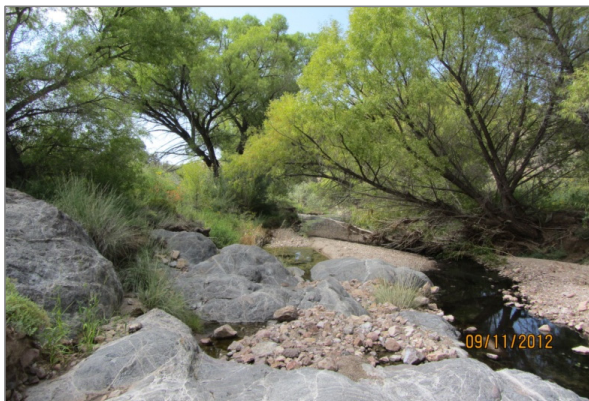
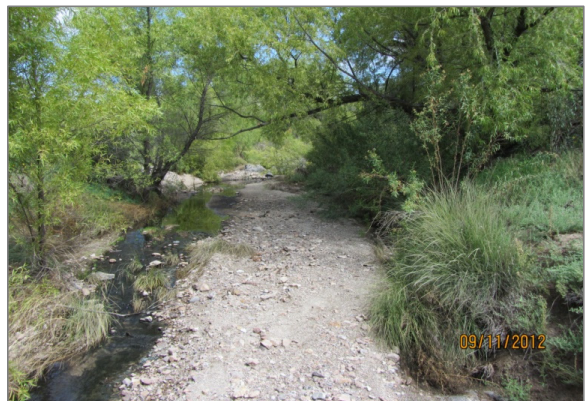
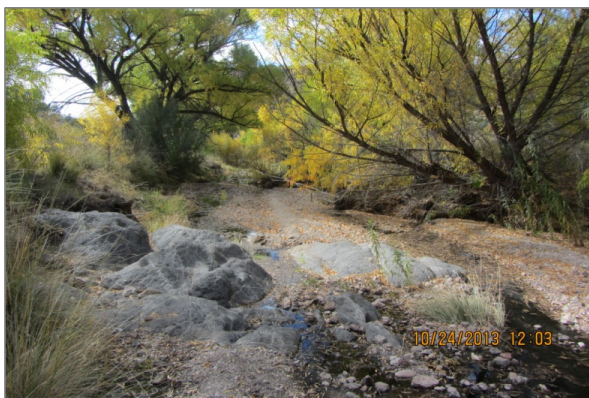
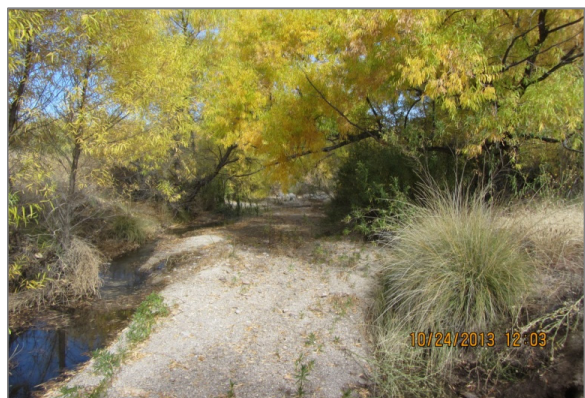
**Photo point 7, view downstream (left) and upstream (right).**

**Top to bottom:** The downstream end of the transition subreach below Horse Canyon. **2009.** Natural bedrock control bypassed by the stream channel; lateral movement exposed the roots of the willow on channel right and eroded the right terrace (left side of upstream view). **2012.** The channel wanders through coarse sand and gravel newly deposited in this reach (note that the upstream view is from nearer the channel than in 2009). **2013.** Aggradation continues.

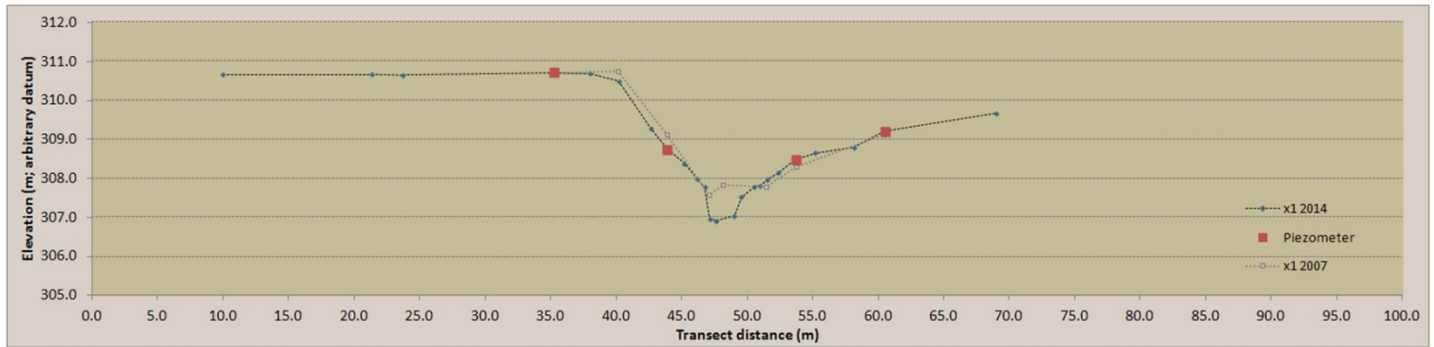
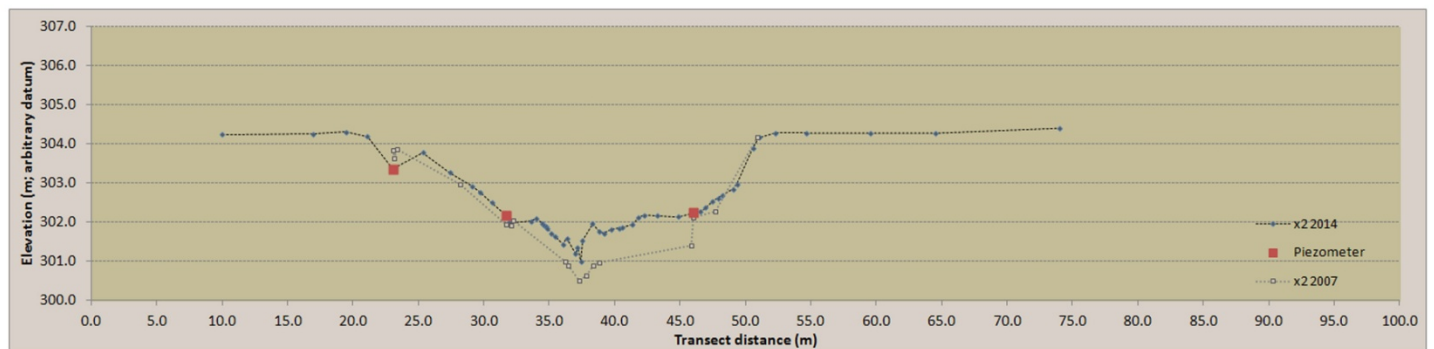
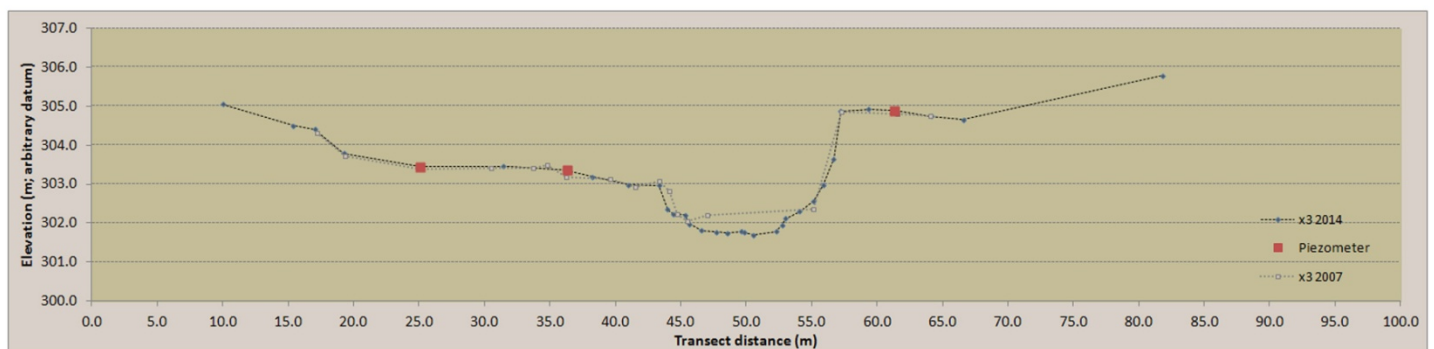
**Figures 2a–2c (top to bottom). Transect lines P1 (x1), P2 (x2), and P3 (x3) as surveyed in 2007 and 2014.** Elevations are based on arbitrary survey datums established for the work: a single datum for the P1-P2 subreach, and a second for the P3 subreach surveys. The vertical and horizontal scales are the same on all graphs. Red squares mark the location at ground surface of each piezometer installed on the transect line; "a" piezometers are farthest left and "c" (P2 and P3) or "d" (P1) piezometers farthest right.

m, and lateral erosion widened the channel slightly. The right floodplain on the P1 line aggraded about 8 cm between the two surveys. However, although the left floodplain at P3 is low and therefore relatively easily overtopped during floods, there was no net deposition on the floodplain between the 2007 and 2014 surveys.

The net result of surface flows through the P2 transect between 2007 and 2014 was very different than at P1 or P3. A substantial volume of material was deposited between surveys, aggrading both the channel and the adjacent floodplains. The thalweg elevation increased about 0.5 m, and the right floodplain aggraded nearly 1 m from 2007–2014.

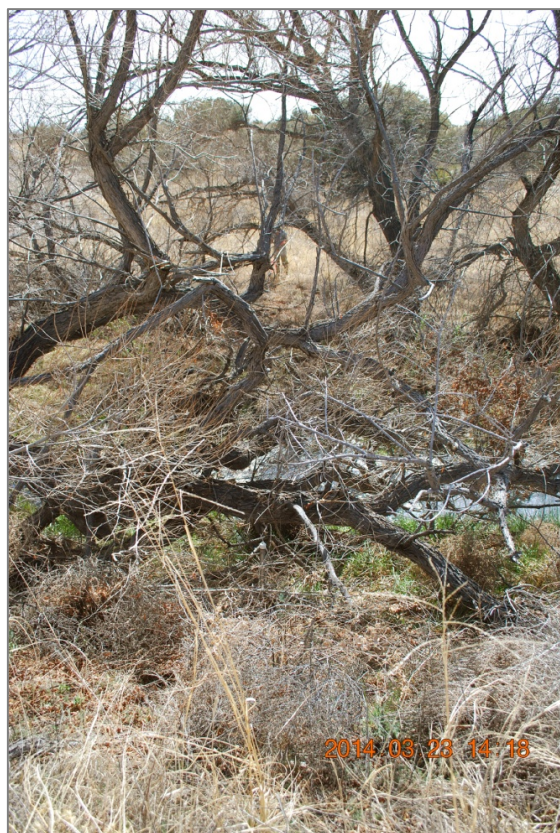
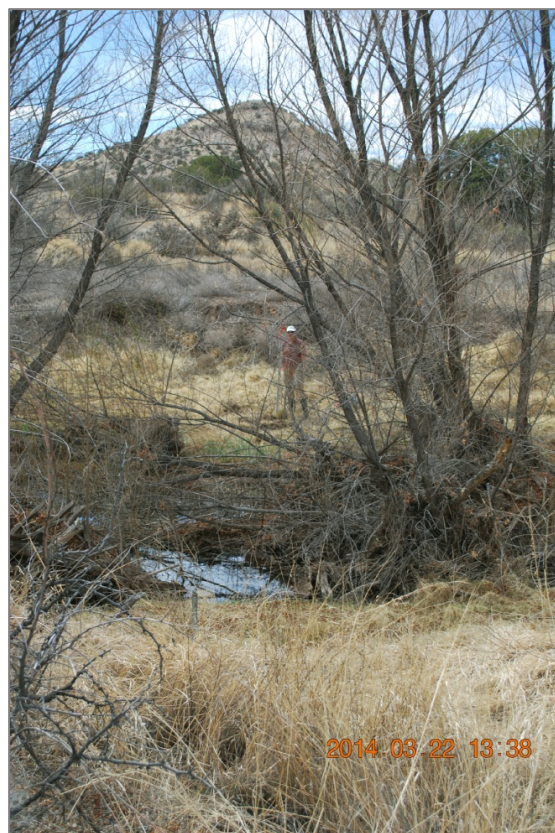
**Figures 3a (left) and 3b: Permanent monitoring transects P1 and P2, March 2014. The person in each image is standing on the transect line.**  
**3a: View left to right across transect P1. Dense herbaceous vegetation occupies the channel banks and both of the large, dormant *Salix* visible are decades old. The pool on the transect was approximately 1 m deep on the survey date. 3b: View left to right across transect P2. Riparian trees (*Populus*, *Salix*) at this transect appear younger than those on P1. Herbaceous bank cover is extremely dense. Maximum water depth on the transect during the survey was approximately 0.8 m.**

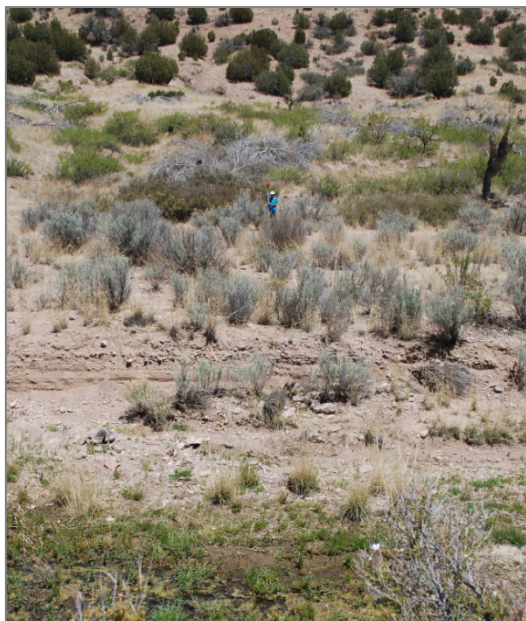
**Figure 4. Sparse floodplain vegetation on transect P3, viewed from right to left. The person at center is standing at the left end of the transect. Shallow surface flow was present in the channel (bottom of image). May 2014.**

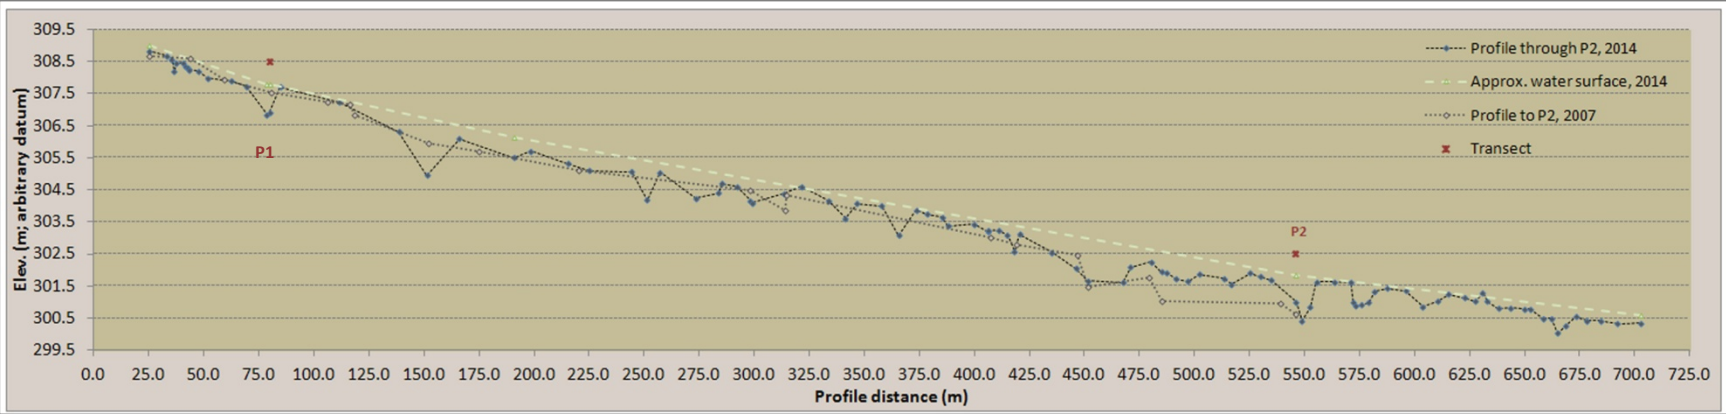
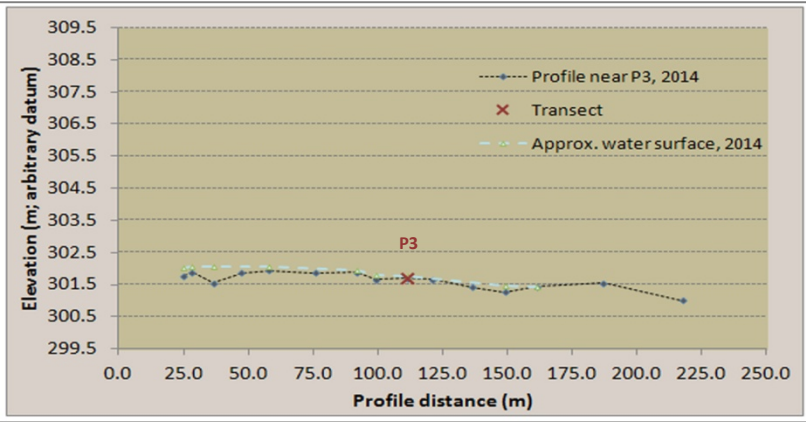
about 0.5%. The only major pool form in the surveyed subreach was near the upstream end of the reach; the pool was 19 m long with a maximum water depth of nearly 0.5 m on the survey date. Obligate aquatic and wetland vegetation species were present, including watercress, cattails, and sedge species (Figure 6), indicating that perennial surface or near-surface water probably now persists at and near this pool.

**Figures 5a (top) and 5b (bottom). Figure 5a: the Burro Cienaga thalweg profile as surveyed in 2007 and 2014 in the subreach from the upstream Pitchfork boundary line through transect P2. Surface flow, including pools nearly 2 m deep, was present throughout the reach during the 2014 survey. The position where each transect crosses the channel profile is labeled. 5b: the thalweg profile mapped through the P3 transect line in 2014. Shallow surface flow was present through most of this subreach in 2014. The position of the P3 transect on the profile is labeled.**

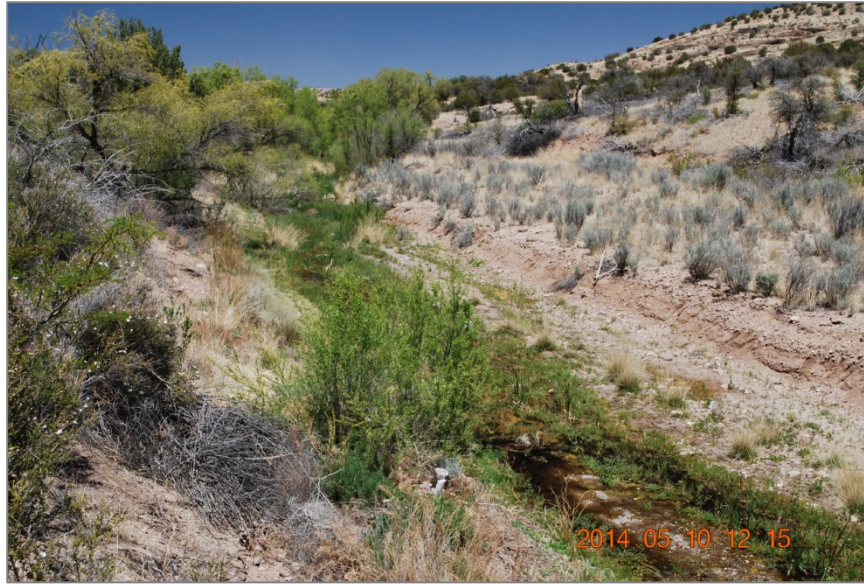
**Figure 6. View toward pool at upstream end of P3 profile from the left terrace on the P3 transect; cattails and other obligate wetland species are well-established on the pool's margins. The juniper post visible in the foreground, bottom center of image, forms part of the post baffle immediately upstream of the P3 transect (Maps 3 and 4).**
