Burro Cienaga Grasslands Restoration Plan & Progress: Pitchfork Ranch – DRAFT

August 2012

Karla Sartor & Dave Gori
The Nature Conservancy in New Mexico

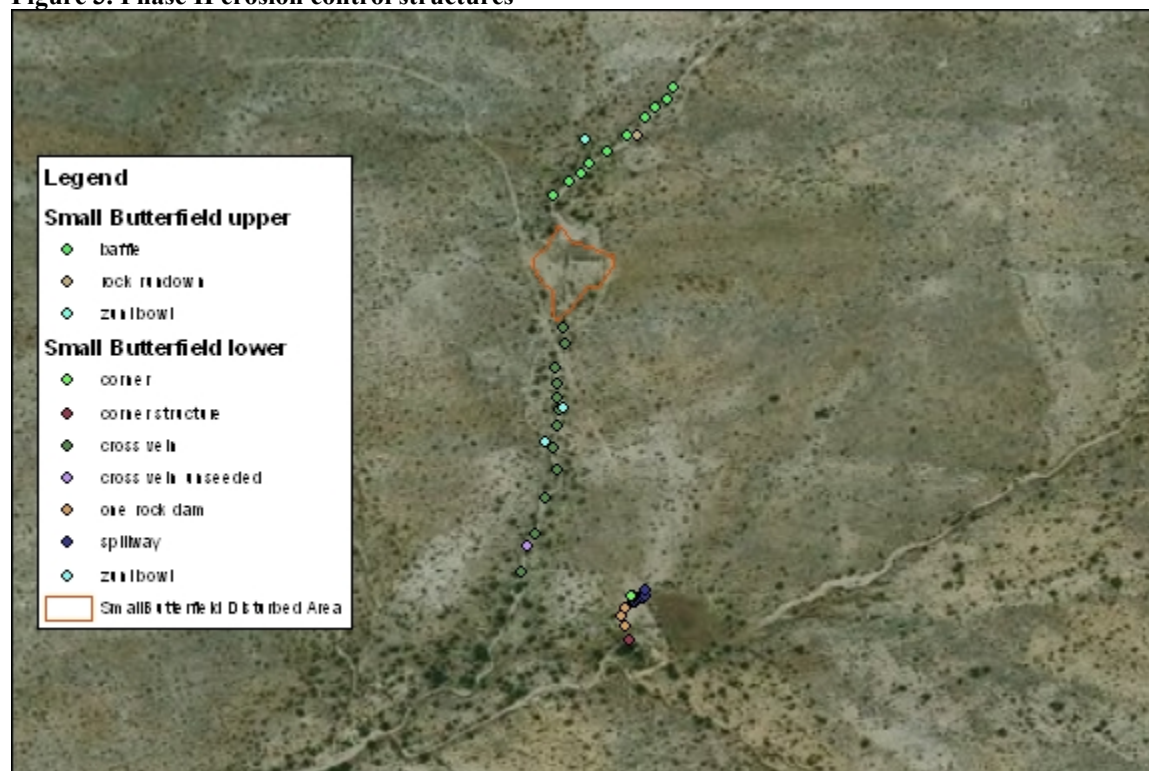
Figure 3. Phase II erosion control structures

The second phase of erosion control structures also included stabilization of a failed dirt tank (Small Butterfield) (photo) and the erosion problems created by it both up and downstream of the tank (photo). When these tanks cause channel incision, this often leads to side-slope erosion as well, which is what we have observed with the Butterfield tanks, and why we felt it was important to repair these channels before they put the entire sub-watershed at risk. This work also included restoration of an intact but failing dirt tank (Large Butterfield) that was designed to reduce further channel erosion, decrease evaporative water loss, and allow more water to recharge the alluvial floodplain aquifer downstream of the tank. Consultant Bill Zeedyk was hired as a sub-contractor to design the most ecologically beneficial restoration for the tanks and areas surrounding these tanks, because channel incision was more severe in these drainages and tank engineering more complex than in the work in Phase I.

It is clear that left unchecked, improperly designed stock tanks alter drainage flow such that soil erosion is a big problem. Prior to treatment, the Small Butterfield Tank had a breached dam in one small section of the center, which likely concentrated large flows and accelerated downstream erosion. Channel incision (4-6 feet upstream and downstream of the impoundment) results in reduced flow available to the surrounding floodplain vegetation. We now see an increase in mesquite encroachment in these former floodplain areas, as deep rooted mesquite were able to access water better than grasses.

The recommendation for the failed dirt tank was to use a bulldozer to level the existing dam, and re-contour the drainage to reintroduce the natural meander this reach had previously. Above the Small Butterfield Tank we used an ‘induced meandering’ approach, using rock baffles to increase sinuosity of the channel, which will eventually return flow to the floodplain (Figure 3).

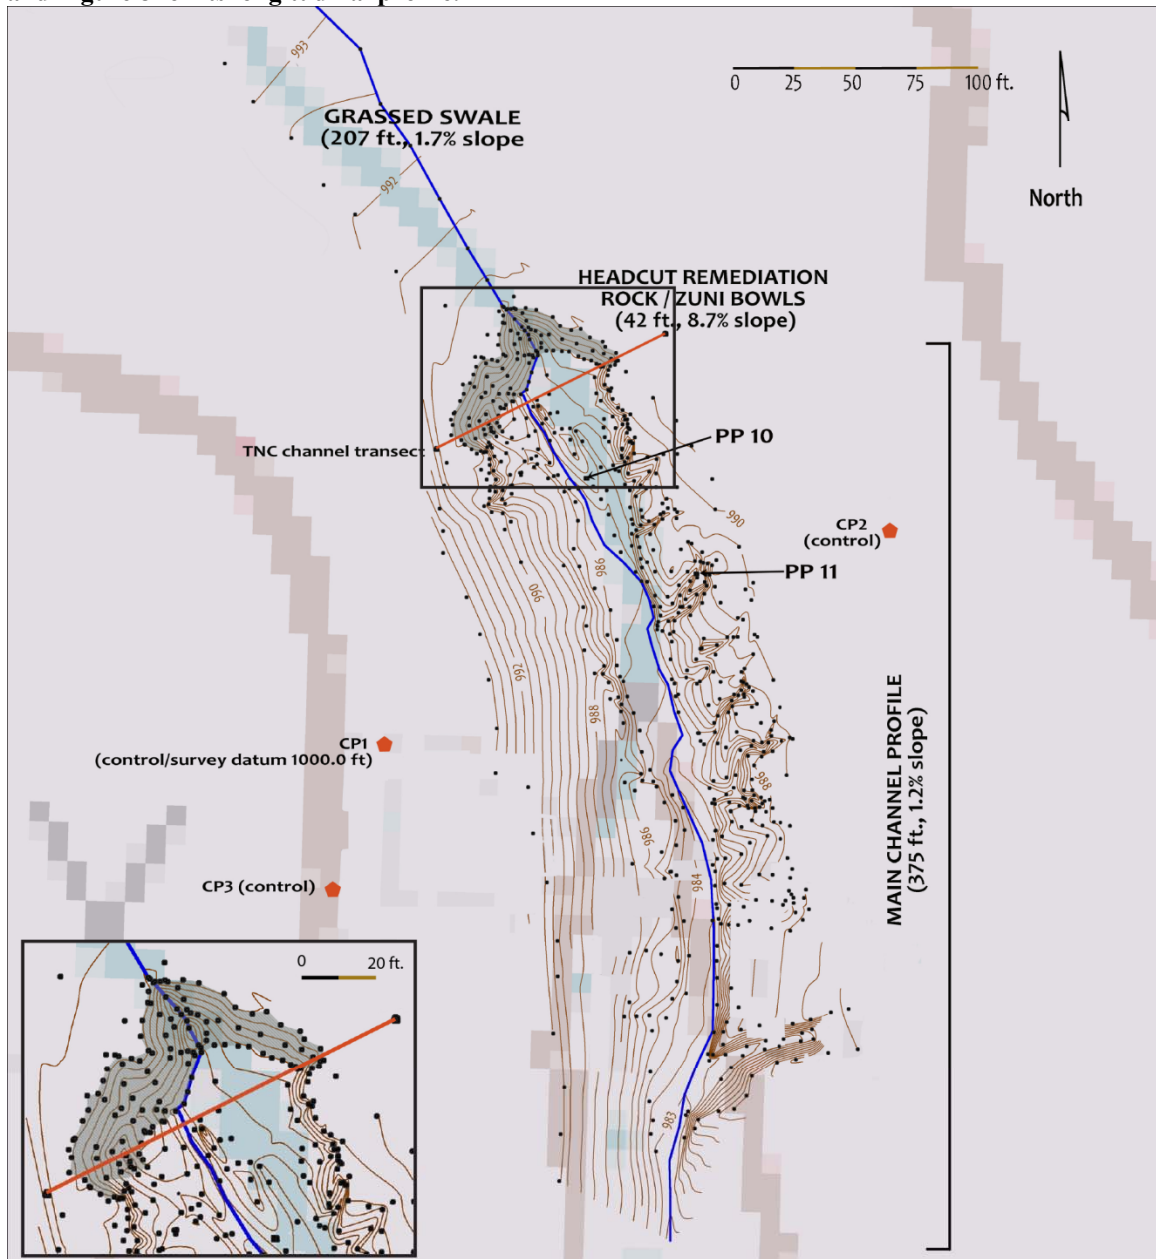
Figure 7. Fine-scale contour map of the large headcut area for monitoring success of remediation. Inset map shows contours of rock structure (gray), including Zuni bowls. See Figure 6 for location of the large headcut, and Figure 8 for its longitudinal profile.

survey of the large headcut area was performed in February 2012, including almost 400ft upstream and downstream of the remediated headcut. This survey method results in a two-foot contour map of the entire area (Figure 7), which reveals double Zuni bowl position, and overall rock rundown slope within the context of the slope of the entire drainage (Figure 8). The survey will be repeated upon visual inspection of soil movement to document exactly where and how much soil has moved around this structure. While more time consuming, and requiring specialized equipment that we contracted with Ellen Soles to use, this method may give a better result than a channel profile or cross section alone could do. With our initial channel cross section measurements, and cross section measurements that can be extracted from this survey data, we will be able to compare the two methods and make a recommendation as to what is the best method to use for monitoring erosion control structures in the future.

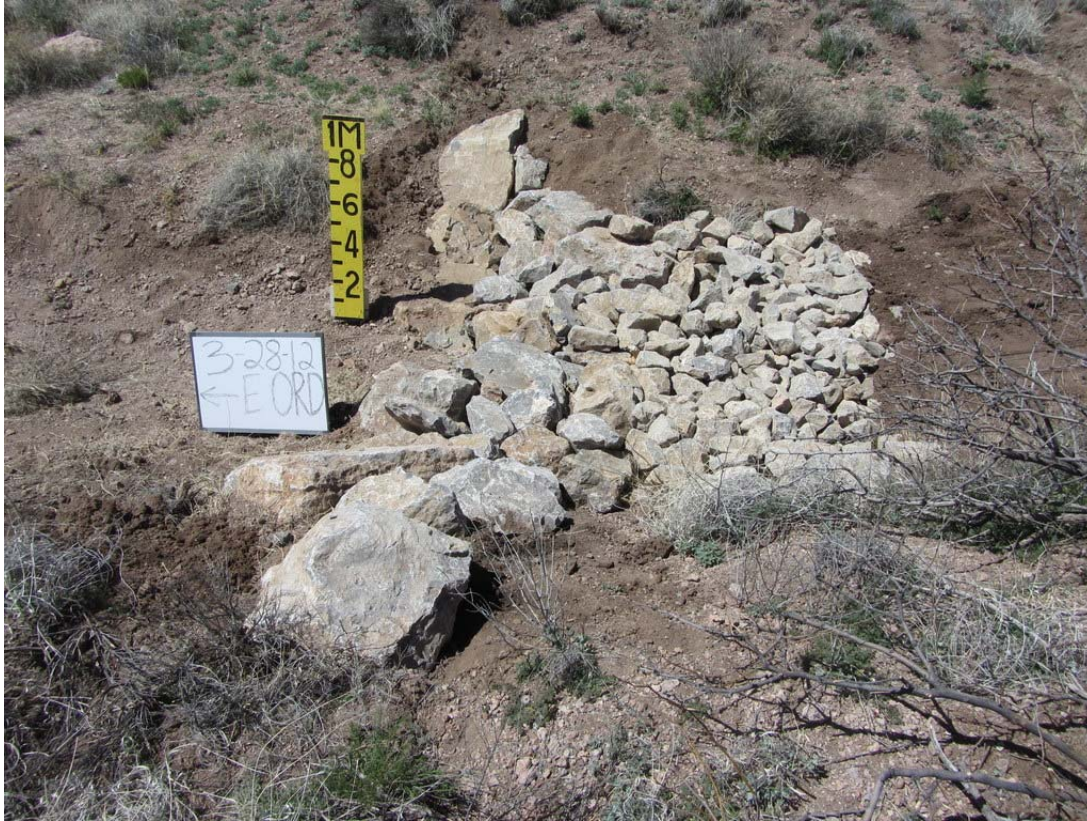
Photo 1. Boulder filter dam
