**Burro Cienaga Hydrological Monitoring Report,  
2007–2014**

Submitted to A. T. and Cinda Cole, Pitchfork Ranch  
by Ellen S. Soles  
Ellen.Soles@nau.edu

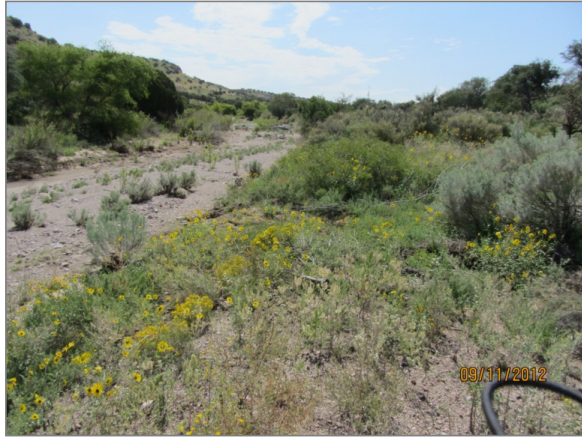
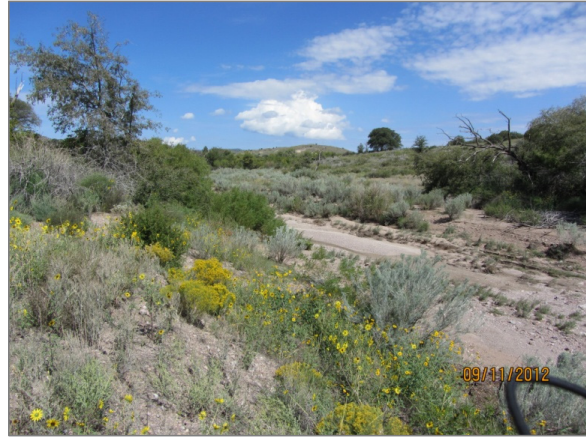
**Photo point 16, view downstream (left) and upstream (right).**

**Both images from 2012.** Intermittent streamflow characterizes the Burro Cienaga stream corridor downstream of the bedrock controls on the channel's course between Horse and Gunn Canyons. The channel and floodplain substrate, composed largely of coarse sand and gravel, is non-cohesive and drains rapidly after surface flow events. Vegetation is sparser and more xeric species inhabit the floodplains than in the upstream subreach, although pockets of riparian and wetland habitat occur sporadically throughout the remainder of Burro Cienaga's course through the Pitchfork Ranch.

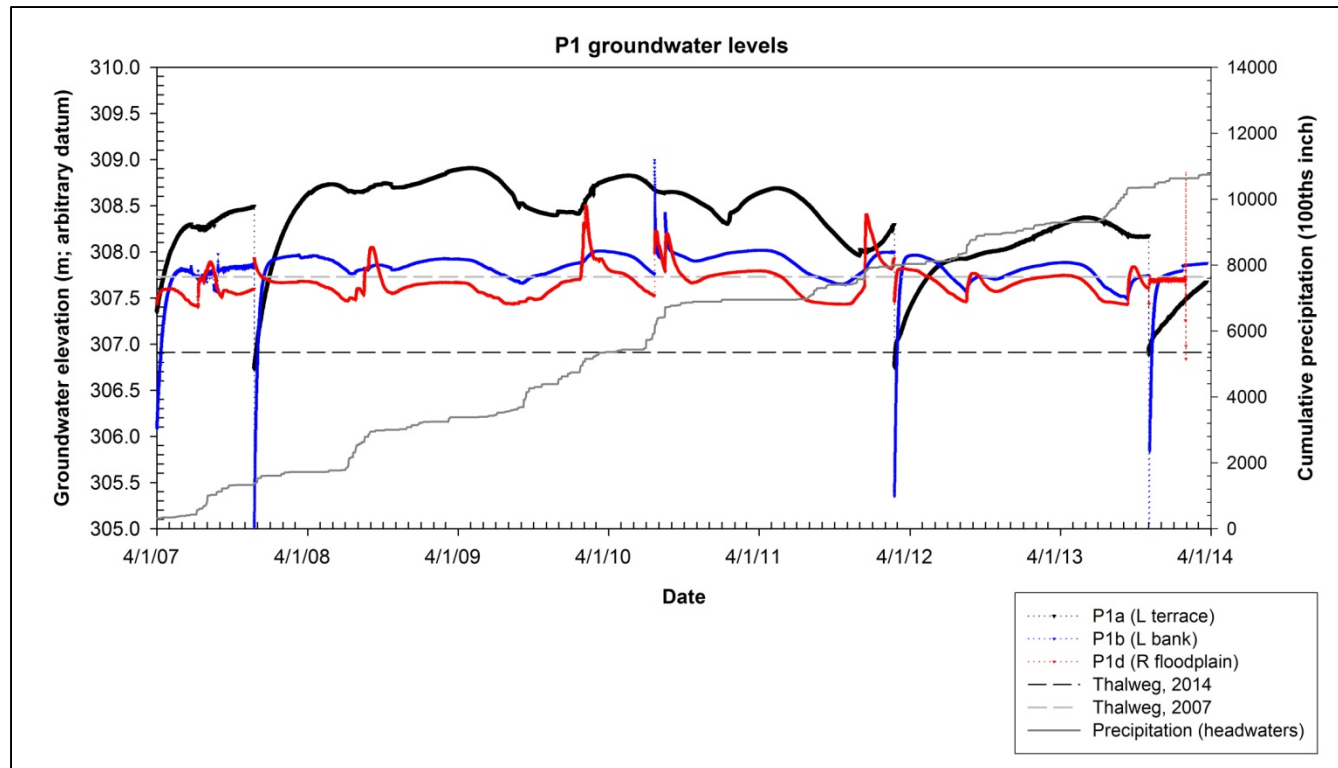
**Figure 9. Water levels recorded in 3 piezometers on the P1 transect April 2007 through March 2014, plotted with cumulative daily precipitation. Dashed lines show the channel thalweg elevation, as surveyed in 2007 and 2014, relative to recorded water levels. The original P1a transducer failed in December 2013, and the P1d transducer in February 2014.**

Transect P1 (Figure 9) was established through a zone where Cienaga Spring emits perennial seepage through the left channel bank. The spring's effects are most visible in the relatively stable groundwater levels recorded in both P1a, on the left terrace, and in P1b, installed directly into the seepage zone on the left bank. On this transect, groundwater levels slope from left to right; regional groundwater emitting from Cienaga Spring may move toward the channel from higher-elevation areas due north of transect P1 (Map 4). An overall seasonal pattern of declining groundwater levels was most evident during the months of June–July; groundwater levels tended to slowly rise during the late winter months. Groundwater levels in all piezometers rose and fell after many increased surface flow events; because no surface flow record exists, it is impossible to say with certainty whether every high flow event elevated groundwater levels. Water levels in P1d, the piezometer installed on the right floodplain (Figure 2a), responded most rapidly to flow events; what was probably the largest flood during the project period, in August 2010, appeared to have reached high enough stage to overtop the P1b piezometer as well.

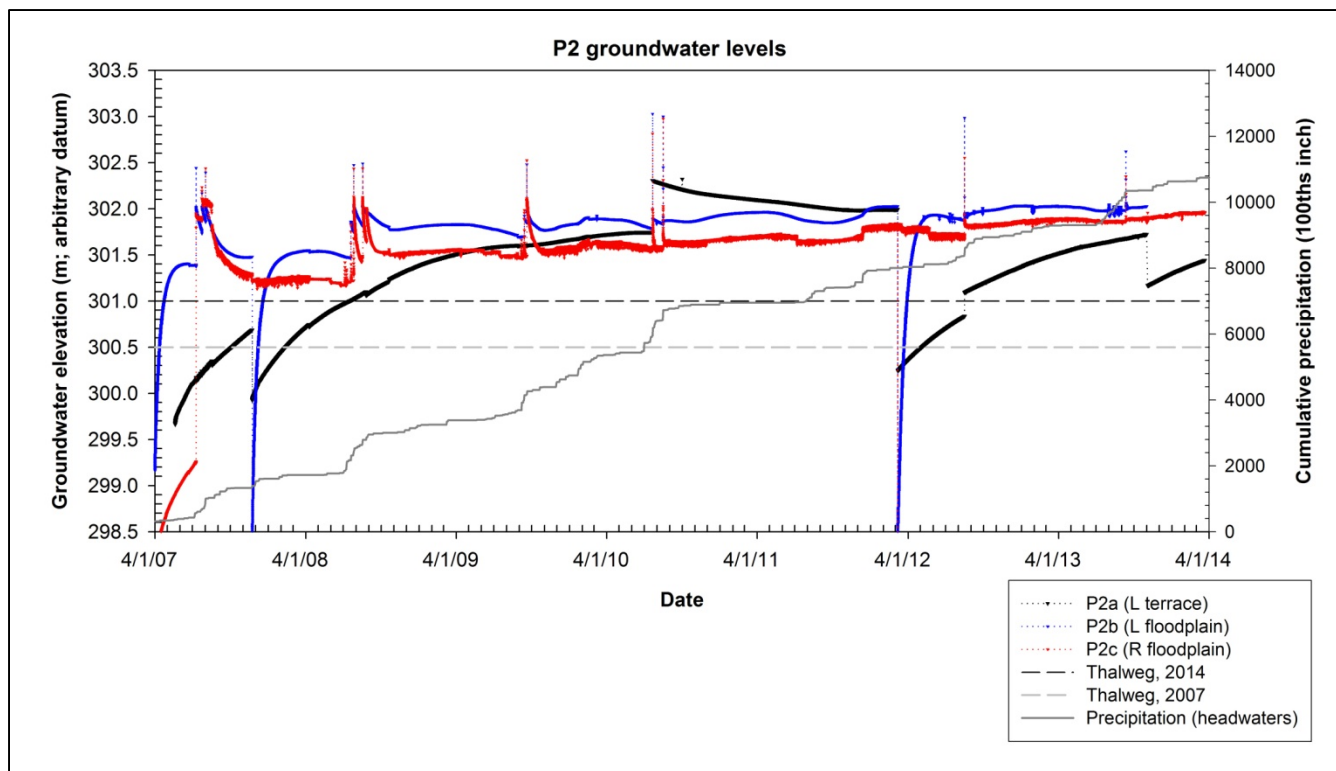
**Figure 10. Water levels recorded in 3 piezometers on the P2 transect April 2007 through March 2014, plotted with cumulative daily precipitation. Dashed lines show the channel thalweg elevation, as surveyed in 2007 and 2014, relative to recorded water levels. The original P2b transducer failed in December 2013.**

Daily precipitation data and water levels recorded at the P2 transect (Figure 10) suggest that another high-magnitude event occurred August 16, 2012. It may have been during this flood that the perennial pool created on the P1 transect between the 2007 and 2014 surveys was scoured (Figure 5a). The accompanying decrease in channel thalweg elevation created this perennial pool; note that although groundwater levels in P1d remained relatively consistent through the report period and were typically *below* the channel thalweg elevation in 2007, groundwater elevation in P1d is now consistently higher than the channel thalweg. The pool was at least 0.5 m deep during even low flow periods through mid-2014.

At transect P2 (Figure 10), any pattern of seasonal change in groundwater levels appears considerably more subtle than on transect P1. Piezometer P2a was installed on the left terrace through dense silt and silt/clay similar to substrate at P1a. Groundwater recharge to this piezometer post-purging was extremely slow but appeared to stabilize at, or slightly above, groundwater levels in P2b, on the left floodplain surface more than a meter below terrace level. However, groundwater levels in the terrace piezometer did rise in response to major flow events; i.e., in August–September 2010 and August 2012.

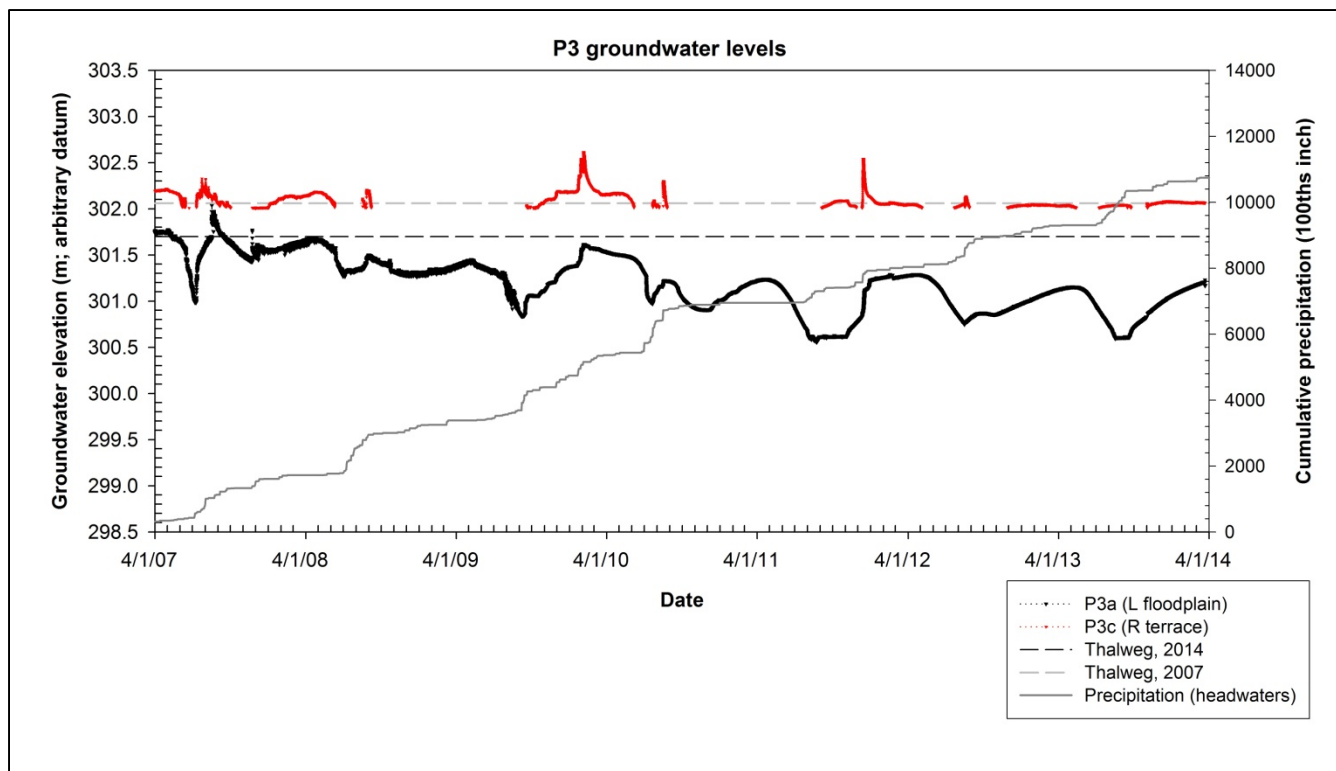
**Figure 11. Water levels recorded in 2 piezometers on the P3 transect April 2007 through March 2014, plotted with cumulative daily precipitation. Dashed lines show the channel thalweg elevation, as surveyed in 2007 and 2014, relative to recorded water levels. Transducers in P3b (a piezometer installed on the left floodplain) failed to report sufficient reliable data for this evaluation, and those data are excluded from the graph.**

Transect P3 (Figure 11) is downstream of the historic cienaga, and close to the upstream end of the reach where surface flow is intermittent or ephemeral for the remainder of its course through the Pitchfork Ranch. Substrate here is much coarser than at P1 or P2 and no riparian vegetation is present on the transect (Map 4). Although 3 piezometers were installed and instrumented on the transect, data from the transducer in P3b were frequently corrupted and unreliable, and so were not used for this report. Groundwater was present in the P3a floodplain piezometer throughout the project period, but in P3c, installed on the high right terrace, groundwater levels often dropped below recordable levels. The data from P3a show a rough pattern of seasonal fluctuation similar to that at P1, although the steepest decline in water levels generally occurred slightly later at P3 than at P1—in July, rather than June. On average, water levels in P3a were about 0.5 m lower than those recorded in P3c, and the groundwater (and perhaps underlying bedrock) appears to slope from right to left at this transect. Groundwater levels appear to have responded to high flow events, although most sharply in P3c. Groundwater both rose and declined more slowly in P3a following the apparent flow events. Although P3c is positioned on the high right terrace, it is also 15 m nearer the channel than P3a, suggesting that surface flow rapidly infiltrates, and drains from, coarse materials in the high right bank.

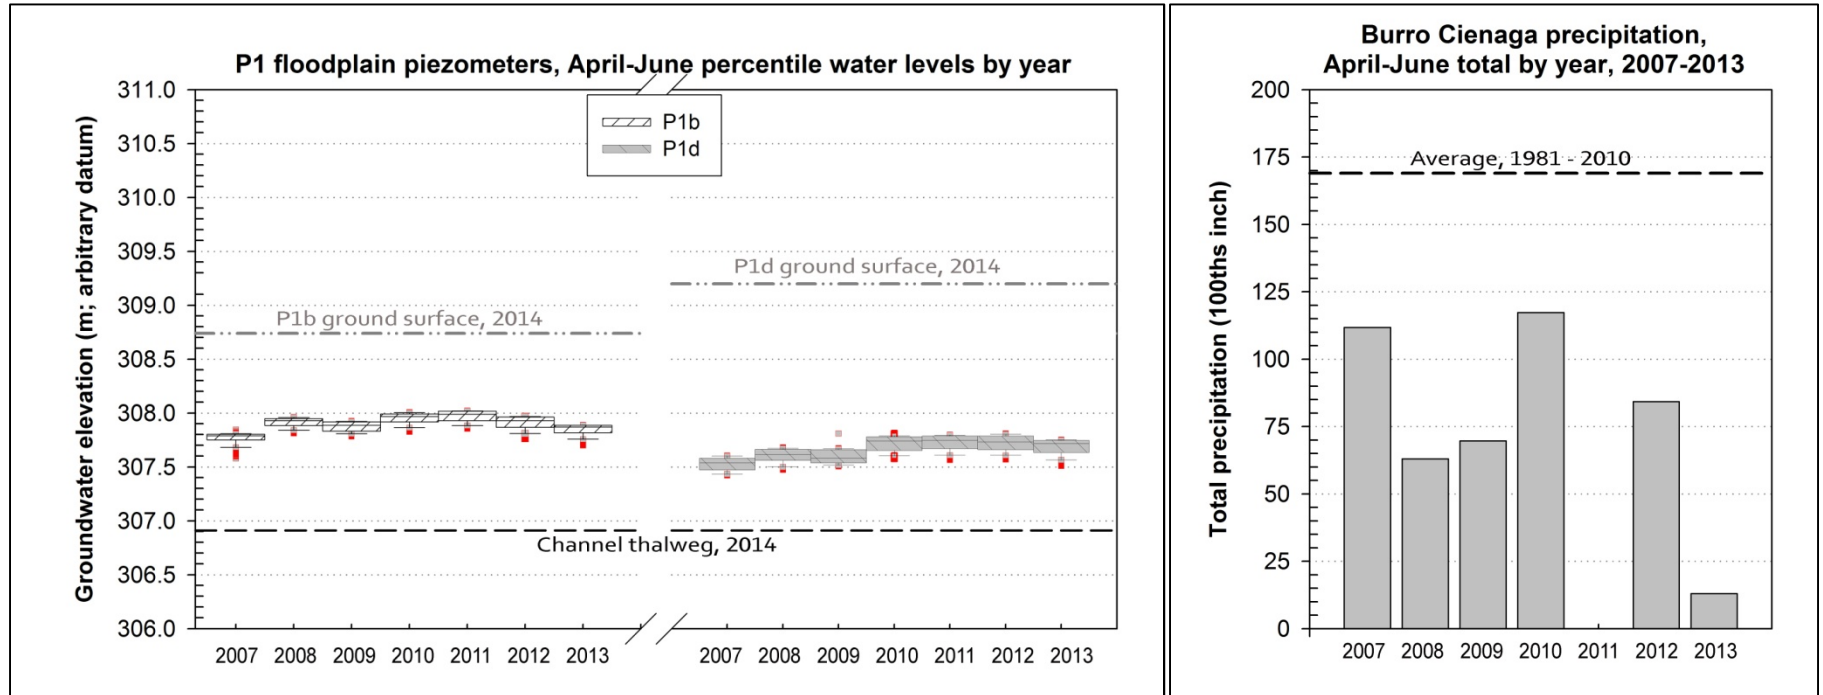
**Figures 12a (left) and 12b. 12a: Percentile groundwater levels relative to channel thalweg and piezometer ground surface in two floodplain piezometers on transect P1 during April–June, 2007 through 2013. Water levels in P1b, where Cienaga Spring emits surface seepage through the channel bank, are on the left, and in P1d, on the right floodplain, on the right. Each box plot depicts all water levels recorded during the 3-month period by year shown on the x axis.**

*P1.* Groundwater levels on each transect during the months of April–June responded differently over time. At transect P1 (Figure 12), groundwater levels from April–June were lowest in 2007, the first project year. Recorded water levels in P1b from April–June are somewhat artificially depressed by slow recharge following installation (water levels during initial recharge appear as outliers below the box); this effect appears slight, however, as groundwater infiltrated piezometer P1d almost immediately, and P1d water levels were also lowest in 2007.

Longer term, regional climate patterns are likely to be more evident at this transect (and especially at piezometer P1b) than at P2 or P3, because of its position at a site of emission for Cienaga Spring. Spring seepage is crucial to perennial flow within this subreach; the streambed is usually dry for at least ½ mile upstream of this point. The groundwater data reflect the strong influence of spring seepage at this transect. April–June groundwater levels after 2007 in both piezometers remained relatively consistent, with 90% of all recorded water levels varying within less than 0.3 m. Median values were generally shifted toward the upper edge of each box (i.e., were higher than mean values), suggesting that steady flow sustained high groundwater levels at this site during these months. Upper outlier values show the brief rises in groundwater levels that occurred during slightly elevated surface flow events, but otherwise scant relationship with concurrent precipitation totals (Figure 12b) is evident.

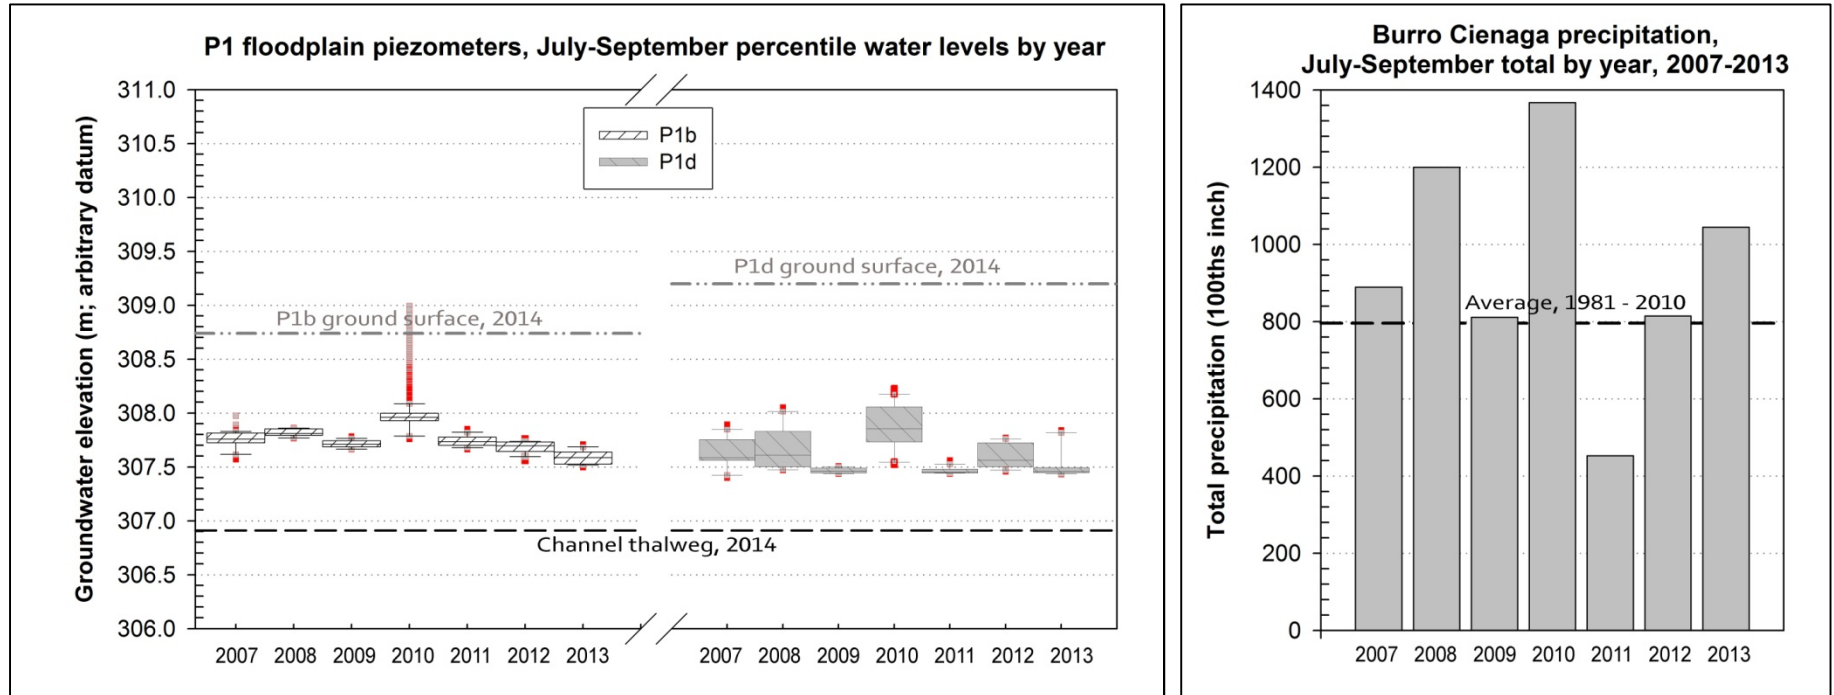
**PI.** The monsoon period, July through September, is typically the period not only of greatest total rainfall, but also when the greatest number of precipitation events occur each year. Monsoon season therefore usually generates more high flow events than other periods. P1 groundwater levels (Figure 15a) resembled seasonal precipitation totals slightly more during each year's monsoon than during the drier spring months—at least until 2012. P1b water levels again varied less overall than those at P1d, even in 2010, when a single extreme high flow overtopped the P1b piezometer. Median water levels in P1b were equal to or slightly greater than average water levels each year. In P1d, however, mean water levels during the monsoon period were substantially higher than median levels in 4 of the 7

years. In other words, the difference between groundwater levels during low flows and those during flood events was great enough to raise the average water level above half of all recorded water levels at P1d, but not at P1b. At P1d, groundwater levels varied over a greater range in all years when above-average monsoon rainfall occurred, except 2013. Declining water levels in piezometer P1b that year suggest either the effects of channel scouring on surface water levels during low flow periods, of extended drought on rates of seepage from Cienaga Spring, or both. At P1d, groundwater levels remained low throughout the monsoon in 2013 except for a brief rise during what was likely a single flow event. A single high flow probably occurred in September that year, after nearly 3.5 inches of rainfall was recorded between August 20 and September 9.

**Figures 15a (left) and 15b. 15a: Percentile groundwater levels relative to channel thalweg and piezometer ground surface in two floodplain piezometers on transect P1 during July–September, 2007 through 2013. Water levels in P1b, where Cienaga Spring emits surface seepage through the channel bank, are on the left, and in P1d, on the right floodplain, on the right. Each box plot depicts all water levels recorded during the 3-month period by year shown on the x axis.**
